How a Tornado Strike in New Castle, Indiana, in 2020 Would Impact the City

An Honors Thesis (HONR 499)

Joseph T. Williams

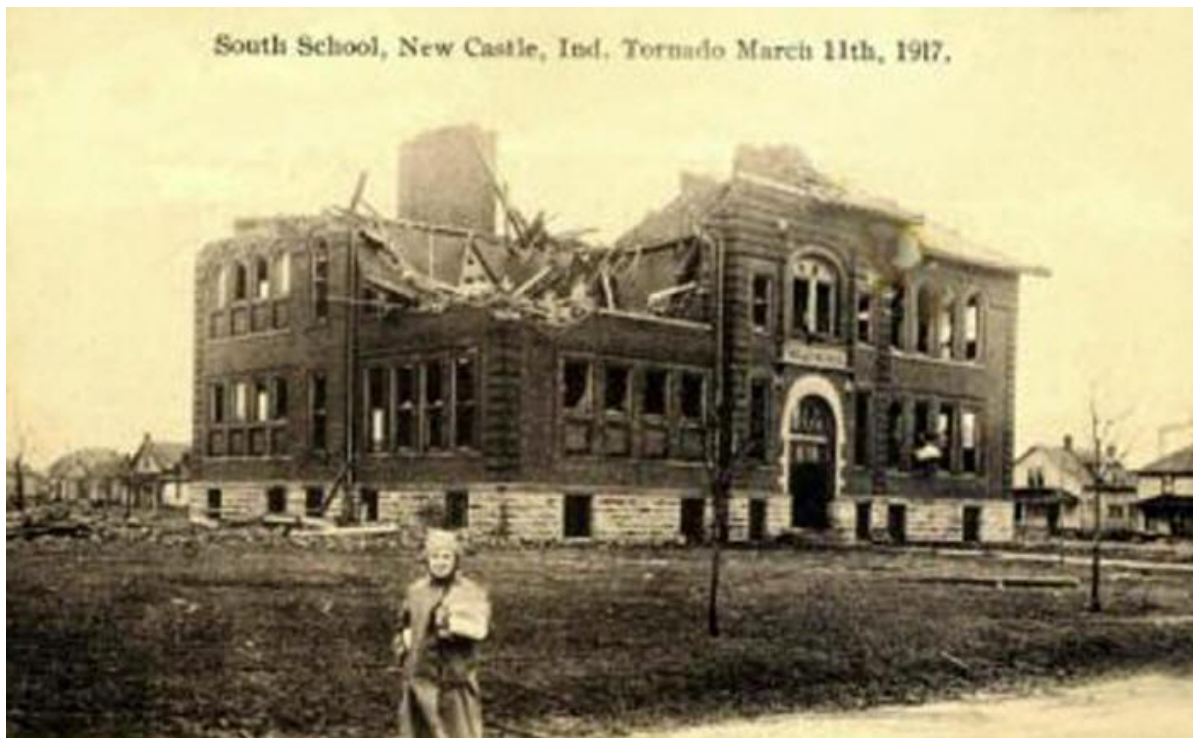
Figure 1: The South School, in this postcard, did not have an address posted on it, making it difficult to figure out where the school would have been. Source: <http://www.gendisasters.com/indiana/21731/new-castle-in-tornado-mar-1917-heavy-destruction-property>

that much of Lincoln Street had suffered damage (Figure 5). The South School had a collapsed roof, several collapsed walls, and damaged windows, indicating that if the tornado had not struck the building, its wind field was large enough to damage it (Figure 1). Finally, photographs of D Avenue show complete devastation, particularly after 20th Street (Figure 6), and A Avenue also shows substantial damage, such as collapsed roofs (Figure 7). This suggests a wide wind field for the tornado as it was exiting the city, although it's just as likely that many of the buildings were not well-constructed and thus collapsed near the tornado's wind field. This helps verify Figure 4's depiction of a widening tornado.

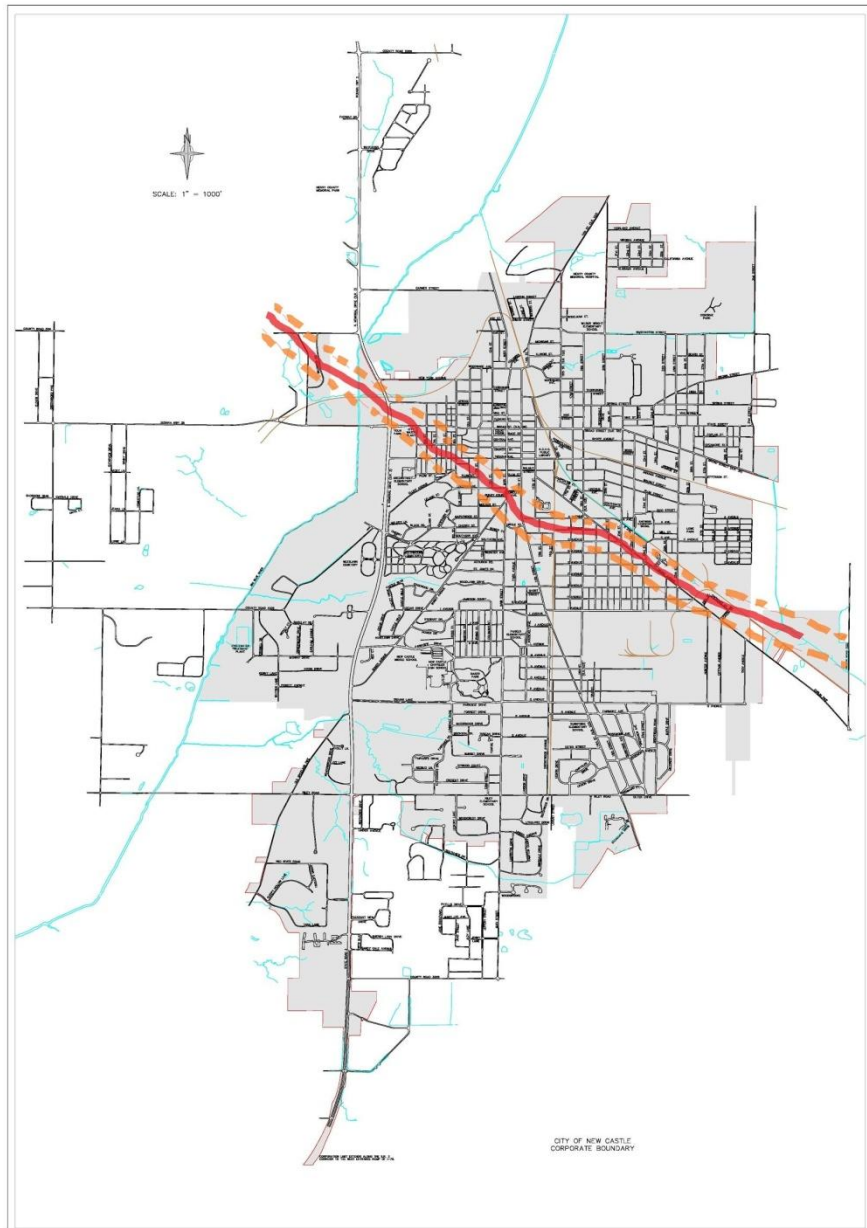
Figure 3: First approximate tornado path, based off secondary sources. The red line is the tornado path, and the orange lines are the “error outlines.”

To figure this out, the author started with the general information of the storm. It was known the storm started on State Road 38, west of New Castle. The storm moved through Lincoln Avenue, 18th through 25th streets, and Grand Avenue (Radford, 2013). Figure 2, which shows a map of New Castle, shows those areas are south of Broad Street, which passes through the downtown area. The storm was also stated to have caused damage on Sixth Street, Eleventh Street and Twelfth Street, which are south of Broad Street and in the western side of town (Perry, 2009). This led to a preliminary map that showed the path of the storm starting on State Road 38, identified by Figure 3, where the red path indicates where the tornado's path was located, and the orange outlines showing the potential error of the tornado path. The error was arbitrary, but it extends out about 500 feet from the red line, since I was trying to account for damage that took place in other locations besides A. Avenue and Lincoln Avenue.

The map was verified by the Henry County Historical Society, which provided another map of the tornado. Once a better map of the tornado path was received by the Henry County Historical Society (Figure 4), the verification stage came into being. The map showed a path similar to the one sketched in Figure 3. Images of the tornado showed

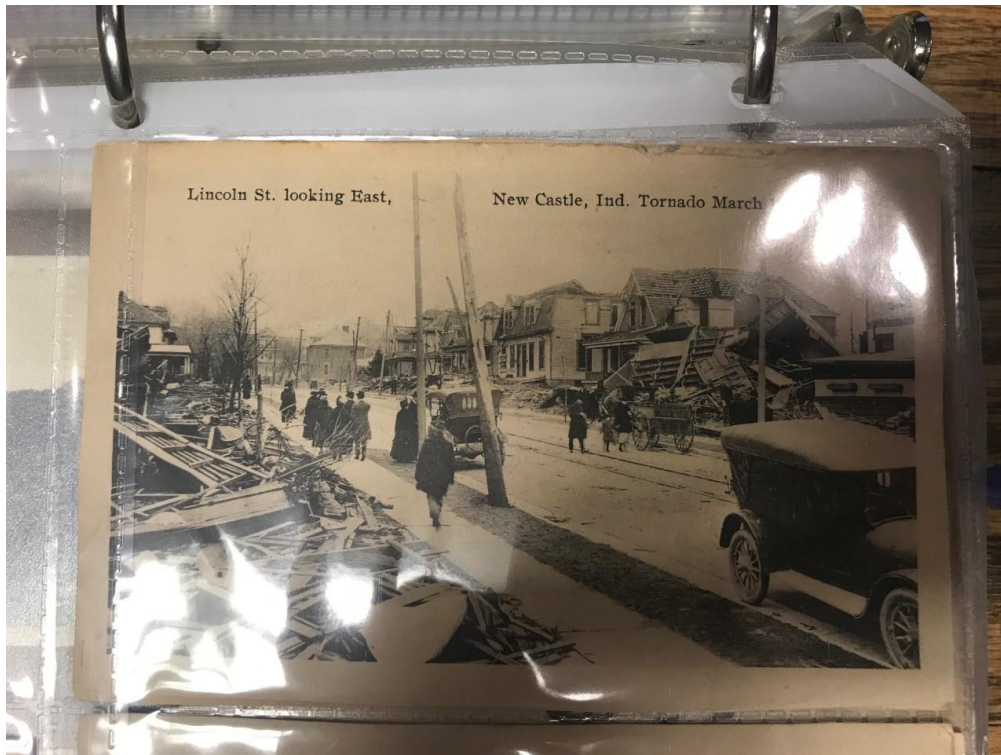
Figure 5: Damaged homes on East Lincoln Street, indicating the tornado moved through here.

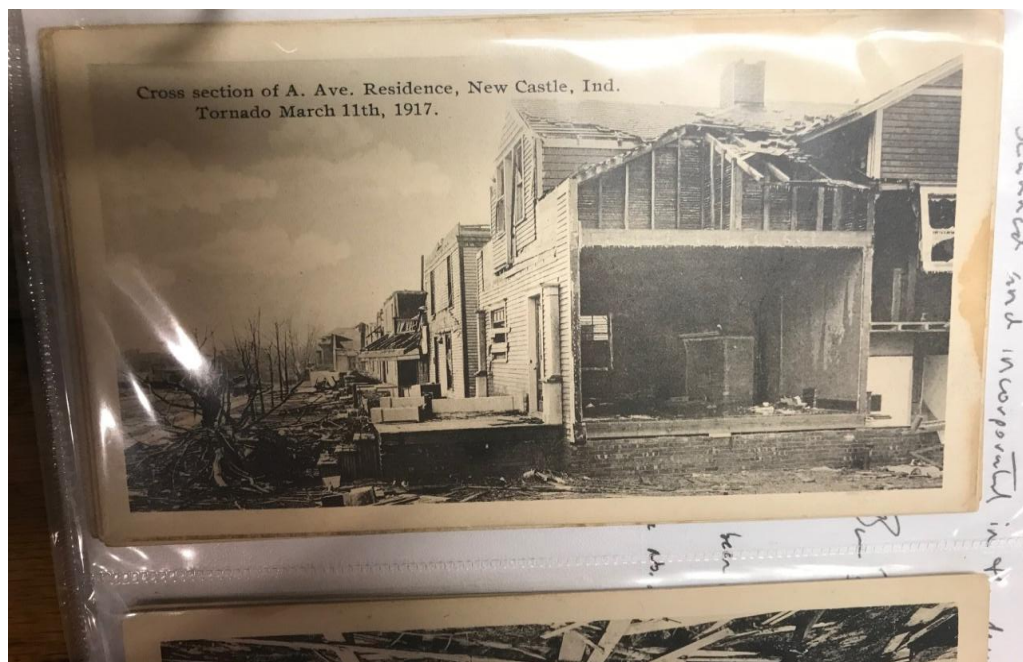
Figure 7: A. Avenue suffered extreme damage from the tornado as well, with many homes suffering collapsed roofs and walls. While not as bad as in parts of D. Ave. and 20-25th Streets, damage was still severe in A. Avenue.
